Degradation Analysis of 8.65-Year-Old Multicrystalline Silicon PV Modules under the Weather Conditions of Sana'a – Yemen

In 2016, an off-grid PV system (14.64 KW) of (48) multicrystalline silicon (mc-Si) modules were installed on the roof of the Yemen Standardization, Metrology and Quality Control Organization (YSMO) in Sana'a – Yemen. In this work, thirty-eight modules from this system were selected for studying the performance degradation after 8.65 years of operation. Degradation analysis of the selected modules was done using visual inspection and current–voltage (I-V) characterization techniques. Results show that the degradation rates in P_{max} of the modules under study, over the outdoor exposure period (8.65 years), were found to be between 2.44% and 7.99% with mean of 5.42% and median of 5.24%. By comparing the annual degradation rates with the industry linear warranty based on nominal power of this module, out of the 38 PV modules studied, only 2 modules have been degraded more than 0.7%/year, which implies that these two modules are likely to fail before 25 years in operation under outdoor conditions of Sana'a, Yemen. The remaining 36 PV modules degraded less than 0.7%

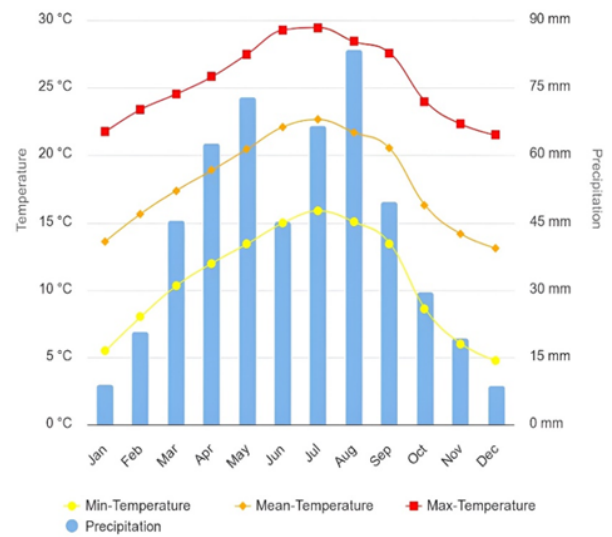
Figure 1. Monthly climatology of minimum, mean, and maximum temperatures, and precipitation in Sana'a for the period 1991-2020 [14].

Sana'a City (15.35° N, 44.21° E) is situated in the western part of Yemen, at an altitude of 2,200 m above the red sea level. Sana'a features the very rare mild version of a desert climate (or "BWk" by Köppen classification) [11]. The low latitude of Sana'a city and its high elevation above sea level has strengthened the effect of UV on the performance of PV modules. The statistics of the irradiance and temperature data can be found in [12]. The average annual of the direct normal (DIN) and global horizontal (GHI) irradiances are approximately 2305 kWh/m² per year and 2341.7 kWh/m² per year respectively [13]. Fig. 1 shows the monthly climatology of minimum, mean, and maximum temperatures, and precipitation in Sana'a for the period 1991-2020 [14].

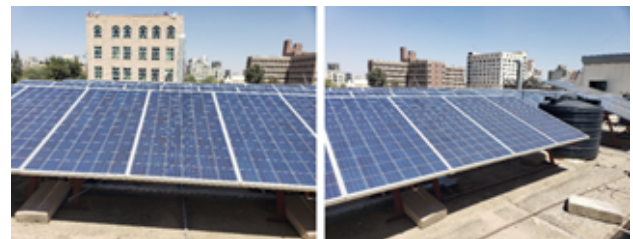
Figure 2. A section of the (P-Si) PV modules that are installed on the roof of the Yemen Standardization, Metrology and Quality Control Organization (YSMO) in Sana'a – Yemen.

In April 2016, an off-grid PV system (14.64 kW) was installed on the roof of the Yemen Standardization, Metrology and Quality Control Organization (YSMO) in Sana'a–Yemen. The system capacity is 14.64 kW and builds from forty-eight multicrystalline silicon technology 305 Wp module (SUNTECH, STP305-24/Vem) rating as shown in Fig. 2. This system remained in work as off-grid until June 2022. After that, it was reconnected to the grid as a part of an on-grid PV system project. Thirty-eight modules (SUNTECH, STP305-24/Vem) were selected for degradation analysis in this study.

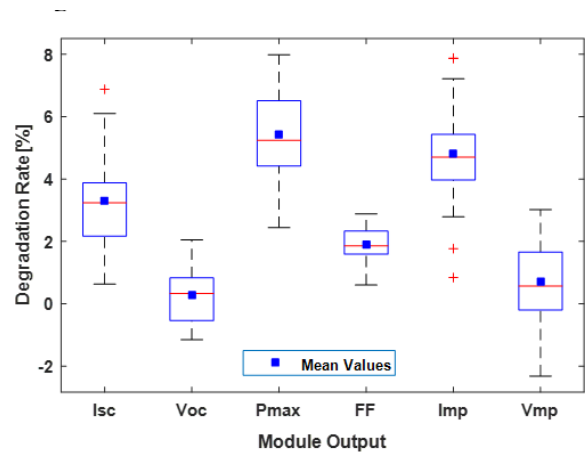
Figure 3. Box plot of the degradation rates of ISC, VOC, Pmax, FF, Imp, and Vmp for the modules under study.

As shown in Fig.3, the degradation rates in P_{max} of the modules under study were found to be between 2.44% and 7.99% with mean of 5.42% and median of 5.24%. The annual degradation rates in P_{max} , over the outdoor exposure period (8.65 years), were found to be between 0.28%/year and 0.92%/year with mean of 0.63%/year and median of 0.61%/year. According to the datasheet of the STP305-24/Vem module [15], the industry linear warranty based on nominal power of this module is described as that 97.5% in the first year, thereafter, for years two (2) through twenty-five (25), 0.7% maximum decrease from the module's nominal power output per year, ending with the 80.7% in the 25th year after the defined warranty starting date. Accordingly, out of the 38 PV modules studied, only 2 modules have been degraded more than 0.7%/year, which implies that these two modules are likely to fail before 25 years in operation under outdoor conditions in Sana'a, Yemen. The remaining 36 PV modules degraded less than 0.7%/year, which are likely to operate reliably for 25 years under outdoor

and (-0.35% to 3.45%) with median value of 1.94%, respectively. Table 2 lists the measured parameters of the I-V characteristics under STC of the PV modules under investigation, taken in November 2024. The corresponding degradation rates of these photovoltaic modules are displayed in Fig. 3.

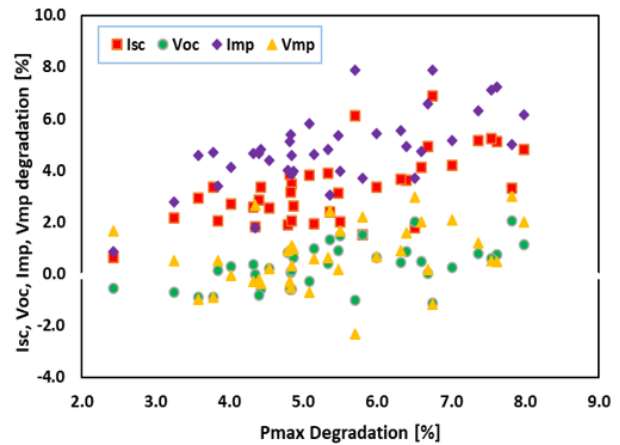
Figure 4. Degradation of P_{max} correlated to the degradation of I_{SC}, V_{OC}, I_{mp}, and V_{mp} for the modules under study

rates shown in Fig. 4 indicate that the P_{max} reductions of modules under investigation are mainly correlated to the losses in the I_{SC} and I_{mp}. Losses in I_{mp} can be ascribed to the decreases of the shunt resistance (R_{sh}). With exception of two modules (YSMO 02, YSMO 33), I_{mp} loss (shunting defect) impacted all modules under study. On the other hand, the reduction in I_{SC} of the modules under study can be correlated to the encapsulation discoloration. According to climate conditions of Sana'a (refer to Section 2.1), encapsulation discoloration is expected to have a significant effect on the degradation of the I_{SC} of modules under study because of these modules being exposed to ultraviolet (UV) light. All modules (except YSMO 02) were affected by this degradation mode. Table 3 summarize the P_{max} degradation rates of multicrystalline silicon modules from different countries with different operational times.

conditions in Sana'a, Yemen. Fig. 4 shows the degradation of P_{max} correlated to the degradation of I_{SC}, V_{OC},

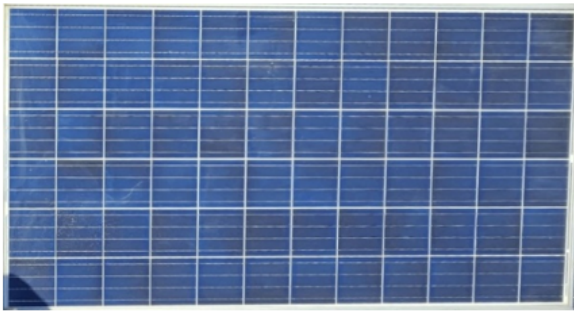
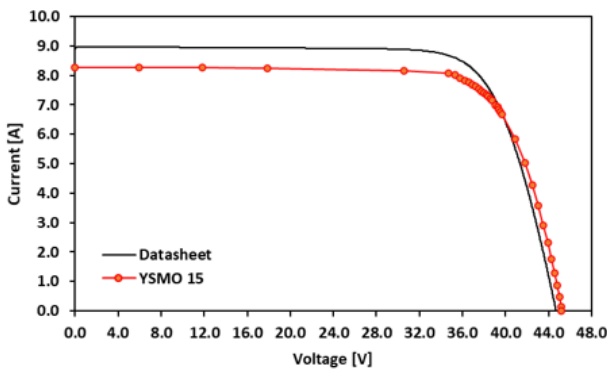
(see Section 3.1). The most noticeable visual defect in the studied modules was a discoloring of EVA encapsulant. Encapsulant discoloration was found on 37 modules with different extent. The encapsulant discoloration reduced the incident photons that reach the solar cells and thus, decreased the I_{SC} and output power (P_{max}) of the modules. Fig. 5 up) shows the module (YSMO 13) with EVA discoloring effect, and Fig. 5 down) shows the I-V curve of this module compared with the datasheet I-V curve of this module. In this module, the I_{SC} , I_{mp} , and FF reductions were 6.88%, 7.87%, and 1.01%, respectively. These reductions lead to a decrease in the P_{max} of 6.76%. This module showed improvements in V_{OC} and V_{mp} . Encapsulation discoloration appears through photo-degradation while being exposed to UV light [23]. Due to the weather conditions of Sana'a, encapsulation discoloration is expected to occur on the modules under study. Minor discoloration of metallisation was found on

Figure 5. Encapsulant discoloration on the module (YSMO 13), **down**) I-V curve of this module compared with the datasheet I-V curve.

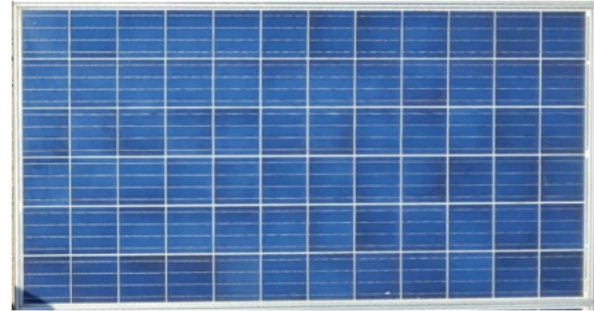
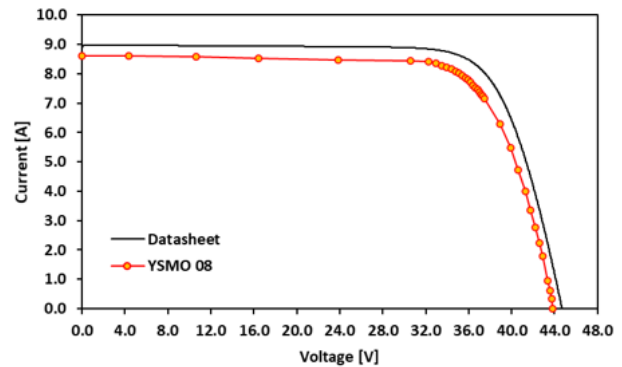
manifestation of both series and shunt resistance due to resistive interconnections caused by the discoloration of metallisation of the module. In this module, the I_{SC} , V_{OC} , and FF reductions were 3.30%, 2.05%, and 2.69%, respectively. These reductions lead to a decrease in the P_{max} of 7.83%. The discoloration of the metallisation likely occurred because of the presence of moisture and acidity in the encapsulant [24, 25].

8 modules. The metallisation of the module consists of busbars and fingers. The discoloration of the metallisation of a module is a type of corrosion of the metallisation. The discoloration of metallisation increased the series resistance (R_s) and led to a reduction in fill factor and output power of the module. Fig.6 up) shows the module (YSMO 06) with discoloration of the metallisation, and Fig. 6 down) shows the I-V curve of this module compared with the datasheet I-V curve of this module. The less steep slope in the vertical leg of the I-V curve is a

Figure 6. Discoloration of the metallisation on the module (YSMO 06), **down**) I-V curve of this module compared with the datasheet I-V curve.
